HISTORIC STRUCTURE REPORT
HOME OF FRANKLIN D. ROOSEVELT

Architectural Data Section

Roosevelt-Vanderbilt Sites
Hyde Park New York

Peggy A. Albee

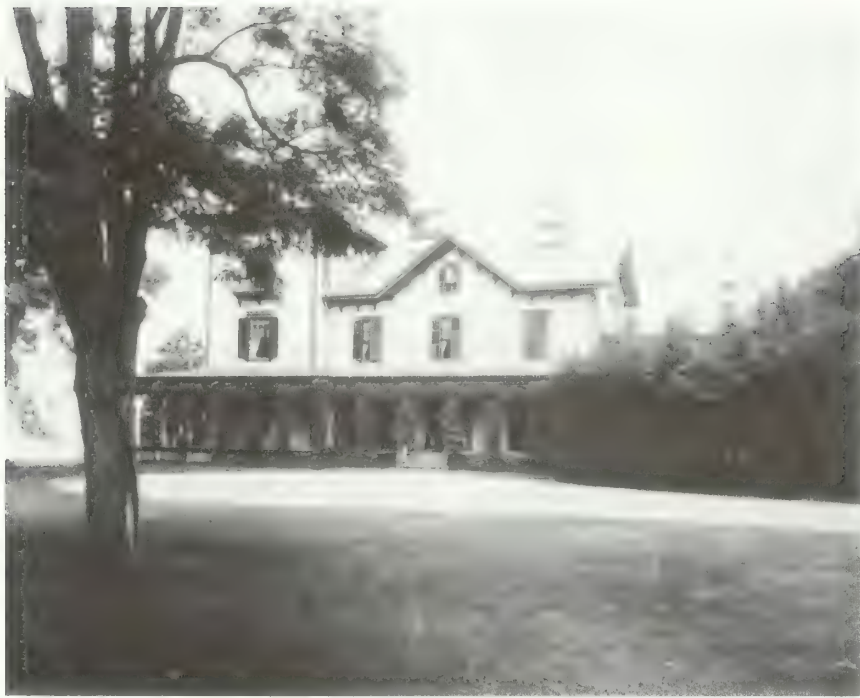
Figure 8. Home of FDR: Front (east) elevation, ca. 1881.

The main house was a rectangular block two and one-half stories high, 46 feet wide by 39 feet deep, and set on a stone foundation. This is based on extant stone foundation walls and early photographs taken in the 1880's (figs. 8-9). Although the photographs were taken after the house's first major remodeling ca. 1850 during the Wheeler occupancy (1845-1867), these elements were not changed at that time. A smaller kitchen wing was centered on the main block's north wall.

The main house was probably three bays wide and covered with clapboards. These are seen in the photographs from the 1880's. Also, clapboards remain in place under the stucco applied in 1915. The first-story plan from the 1915 alterations (Appendix A, Drawing No. 6) does contain information that suggests five bays were reduced to three at that time: the drawing calls for two areas at the south end of the east wall to be constructed with new wood. These areas look much like window openings, and indeed probably were, but ones that were added between 1893 and 1901. (They do not appear in figure 8, nor in figure 12, a 1893 painting of the house.)

The original color of the house is unknown. Figure 8 shows the house as having a light-colored body and dark trim, with the same bichromatic treatment used on the chimneys, chimney pots, and front doorway. This scheme is reminiscent of the Italianate style, and so figure 8 is thought to be the earliest photograph of the house. The house appears to be a darker color in the other early depictions, more in keeping with the later Victorian era. These depictions include photographs taken before 1887 and in 1900, and the Lounsbury painting dating to 1893.

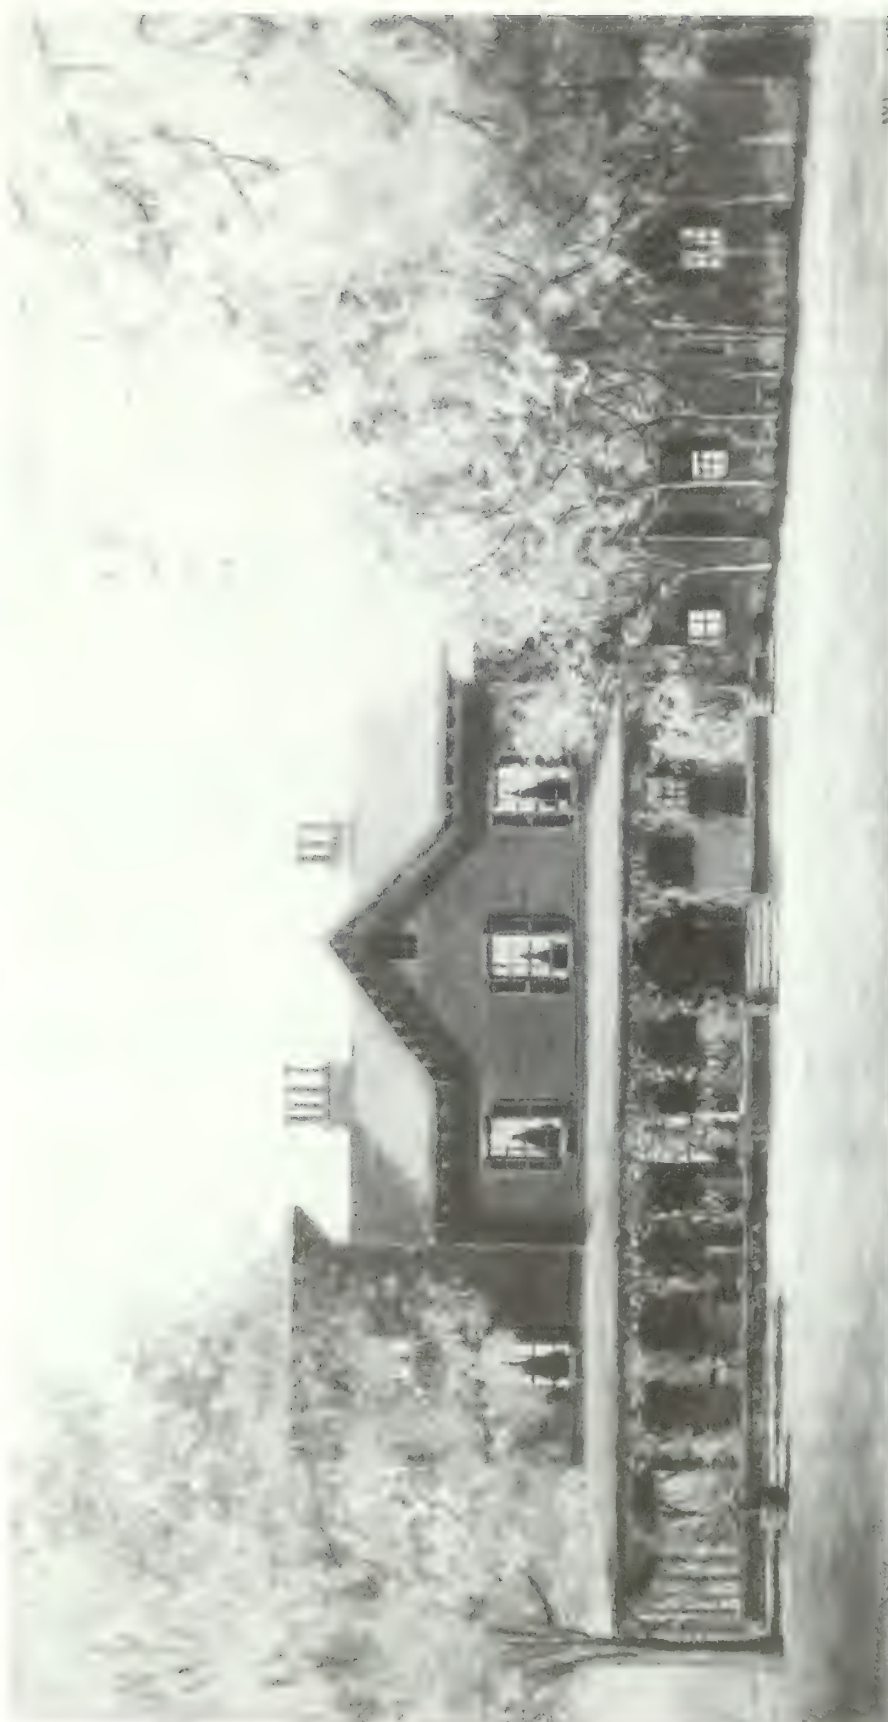
Figure 12. Home of FDR: Oil painting of front (east) elevation, May 1893.

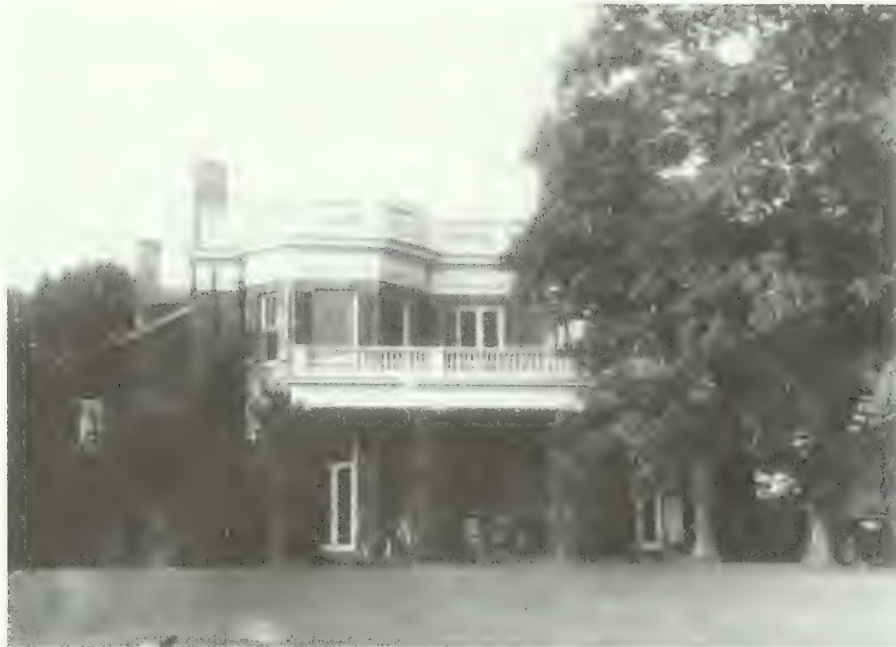
Figure 26. Home of FDR: View from the south, 1932.

The drawings also show that the existing balustrade of the 1900 second-story octagon addition was to remain. It was removed before 1932 (fig. 26). The roof vent barely visible in the same illustration is reflected in the drawings (Appendix A, Drawing No. 8).

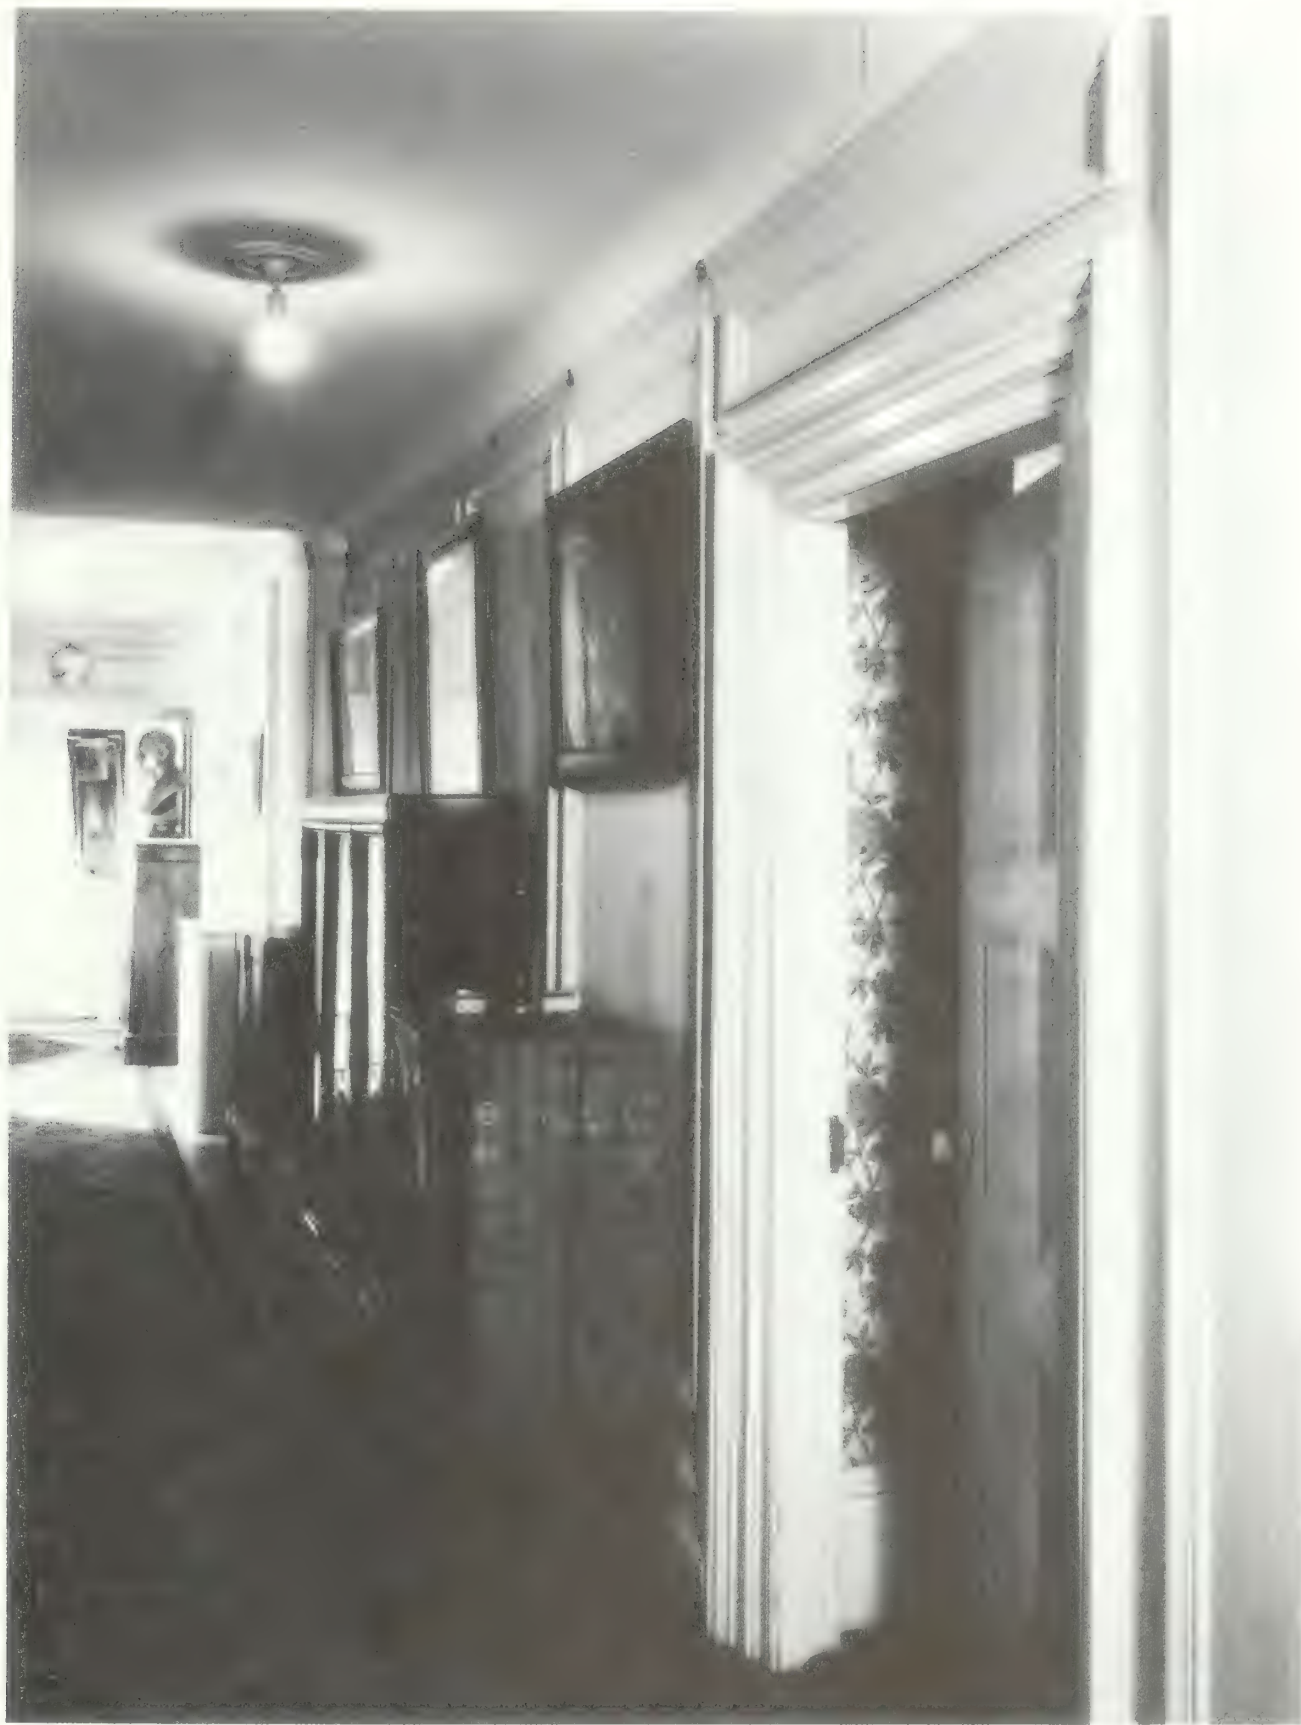
Figure 29. Home of FDR: Second-story Main Hall, looking south, 1941.

The structural problem that occurred during 1915 may never have been fixed correctly. Photographs of the second and third stories from the 1940's (figs. 29, 35) show stress cracks in the plaster. These same types of cracks are continuing today.

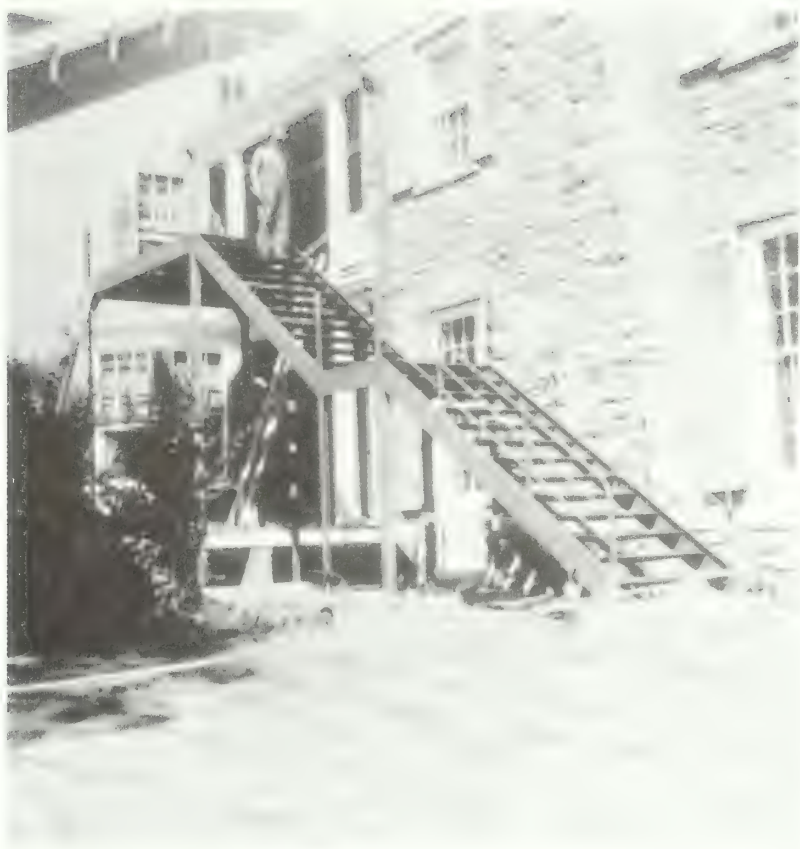
Figure 36. Home of FDR: New egress stair, looking northeast from southwest lawn, ca. 1949.

The West Porch was converted to a visitor and emergency exit in 1949,¹⁰ by the construction of an exterior stairway (fig. 36). After the 1982 fire, a new fire-escape stair was installed. This necessitated removal of some original fabric. A section of the wooden balustrade at the second story had to be removed to accommodate the egress in 1949, but more than three-quarters of it remains.

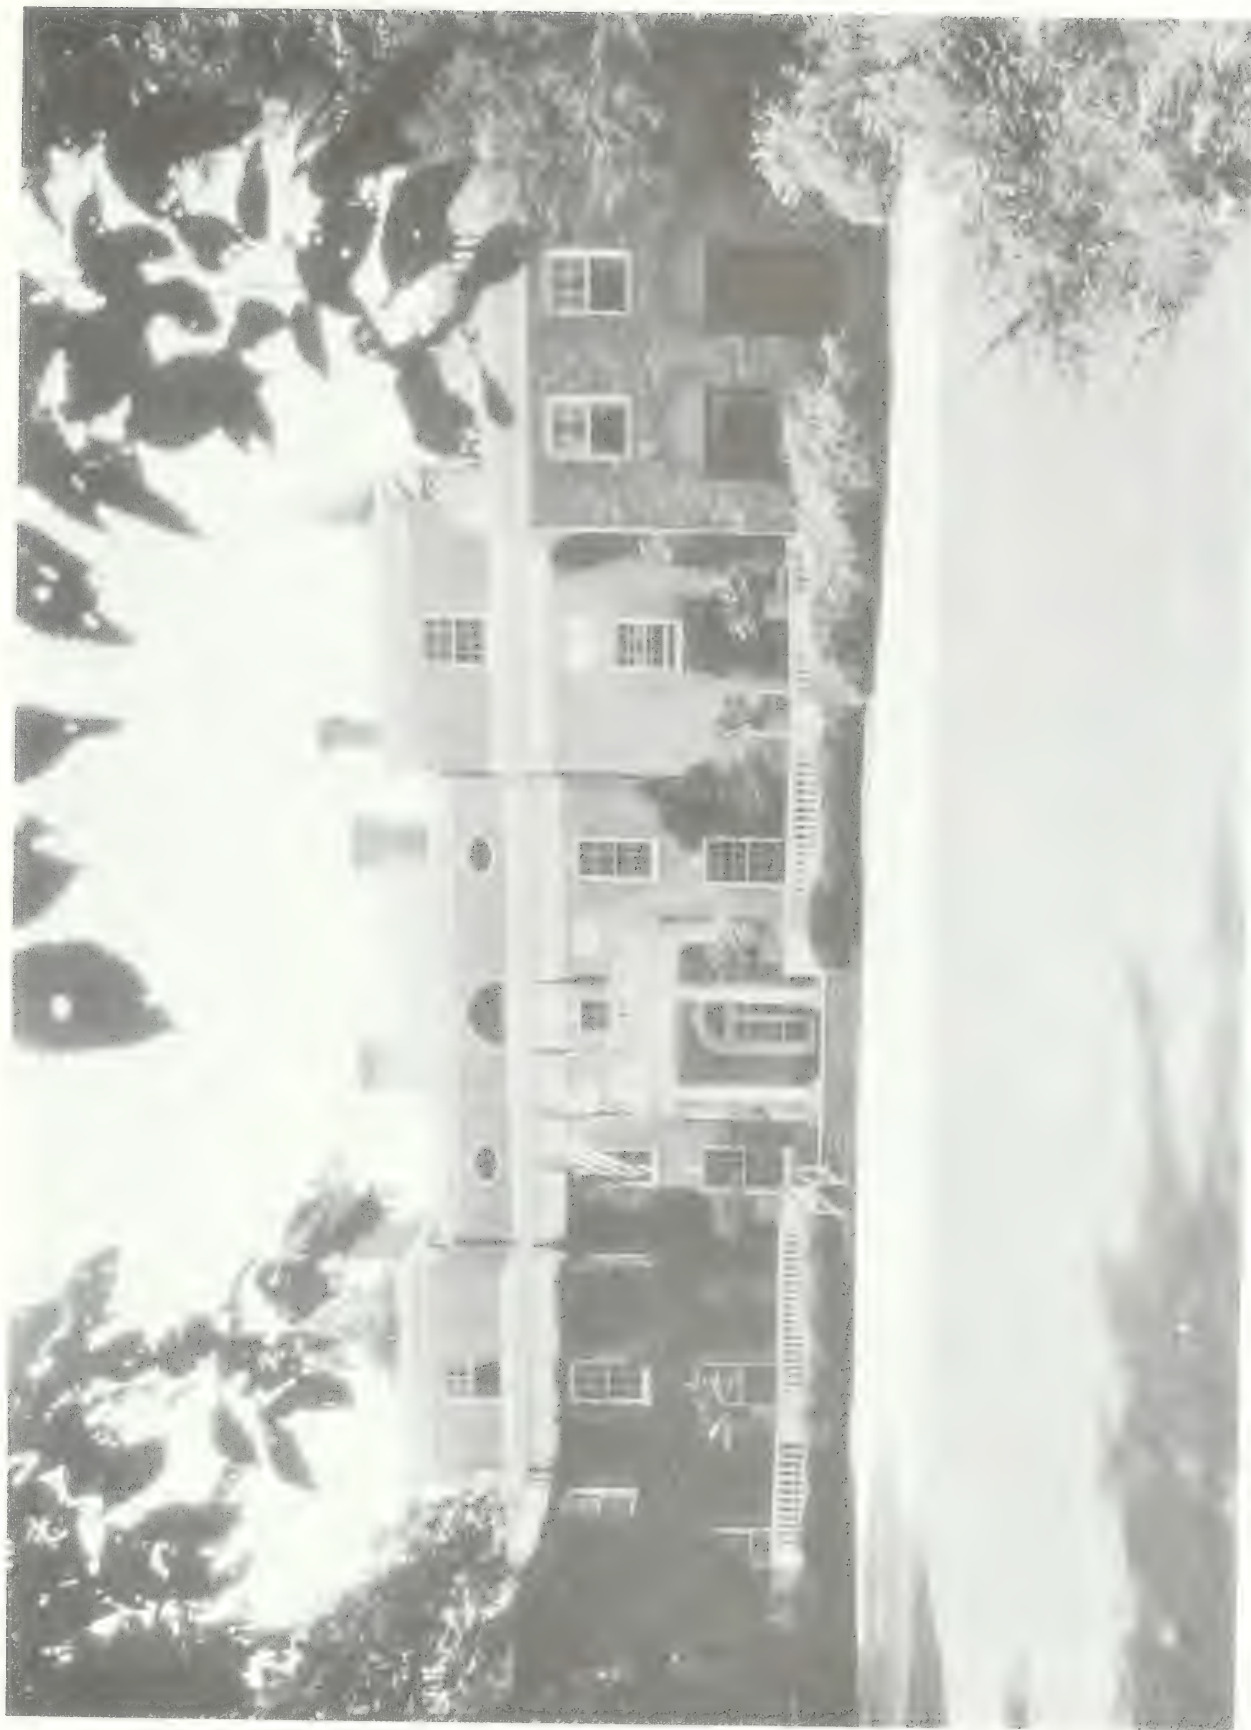
Figure 47. Home of FDR: Front (east) elevation, 1941.

not appear to show this parging, leaving one to wonder about its historicity (fig. 47). A white-painted skirt board runs above the foundation.

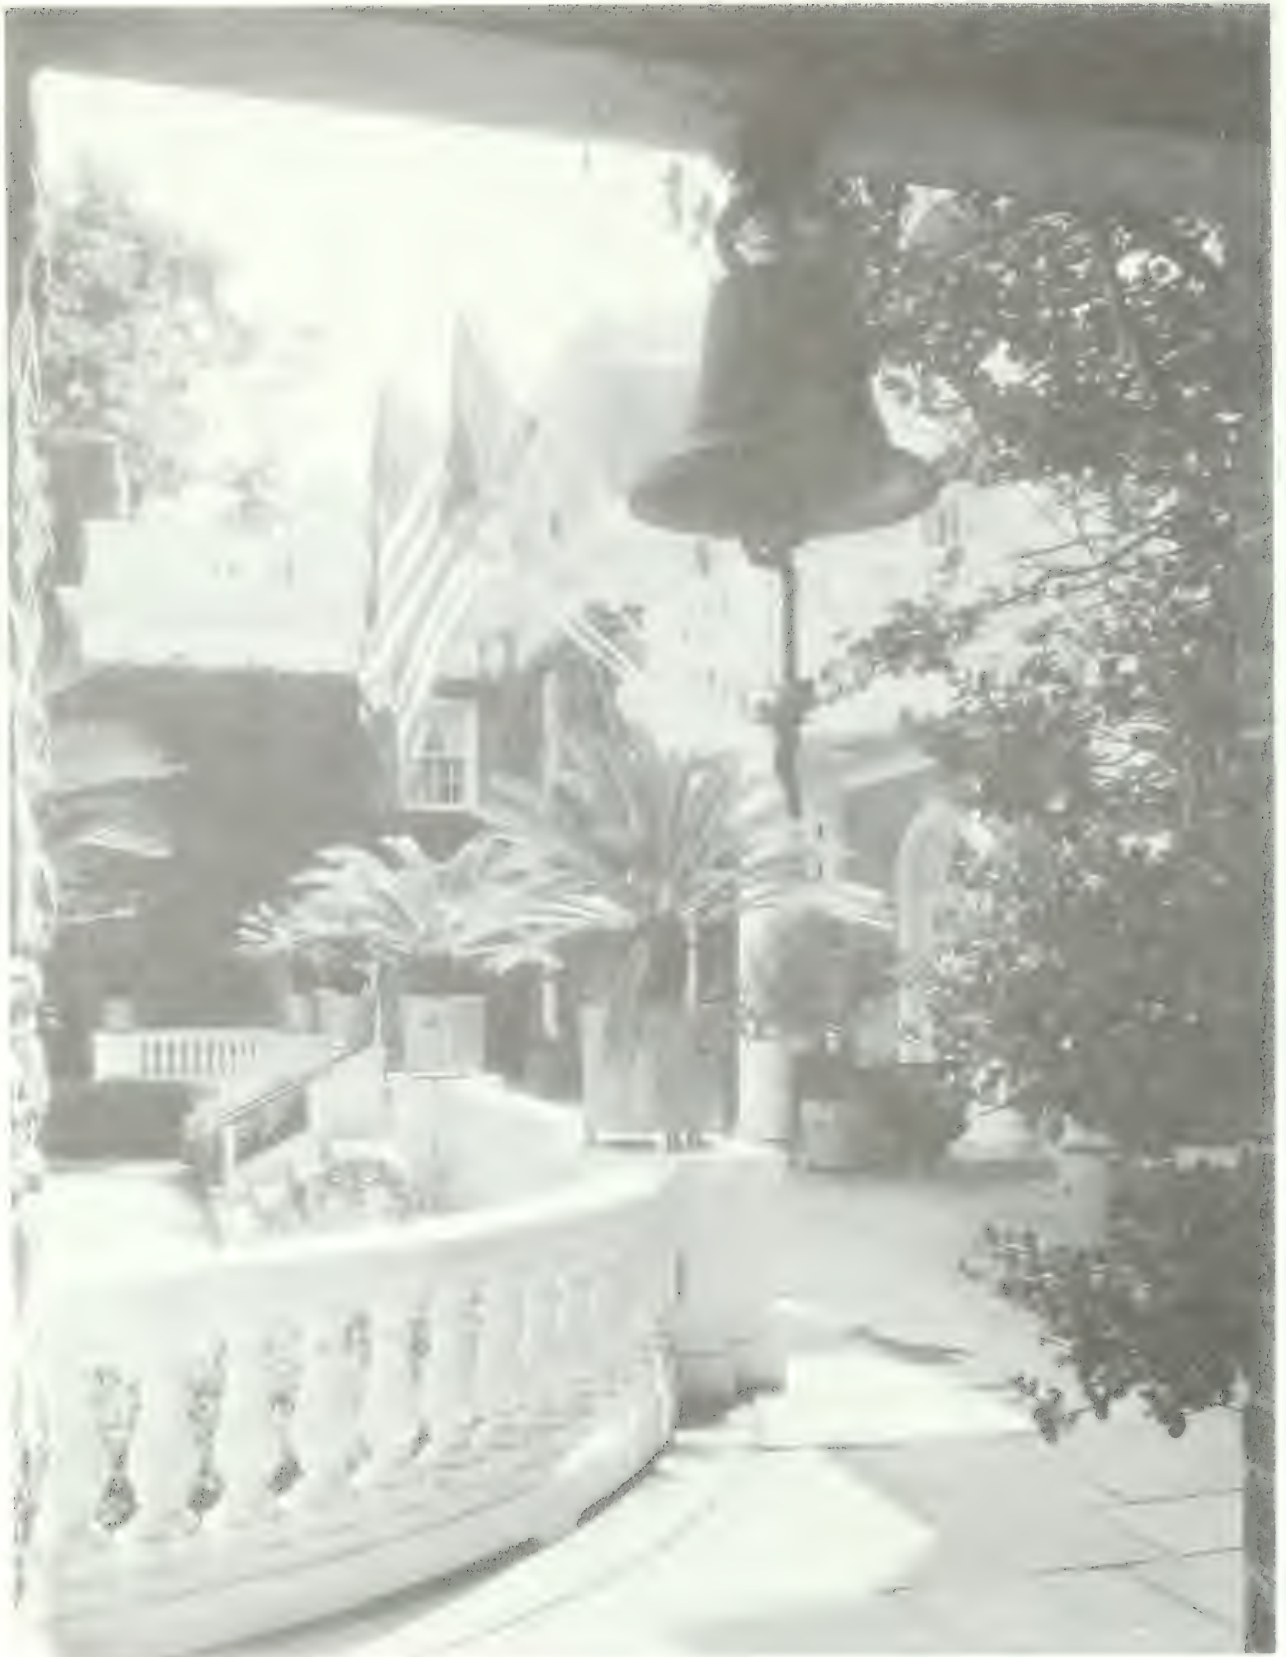
Figure 48. Home of FDR: Front (east) terrace, 1941.

Franklin probably considered the bell part of his naval history collection and therefore appropriate to incorporate it into his newly renovated home (fig. 48).

The center-entrance house is approached by the east terrace, with centered steps consisting of four risers topped with bluestone treads. The steps are flanked by gracefully curved wooden balustrades composed of turned balusters, three wooden pedestals per side, and a canvas-covered wooden railing (fig. 48). The balustrades, anchored to the bluestone edging of the terrace, form the eastern perimeter of the terrace and provide a visual connection across the front of the house from fieldstone wing to fieldstone wing. All wooden elements and the canvas are painted white. The balusters' paint is cracked and in fair condition. Park records suggest that the canvas covering the balustrade railing was replaced in 1974.³ It still appears to be in good condition.

A lighting fixture is centered in the portico's ceiling, but the existing frosted-glass globe is stylistically more modern than the historic 1945 date. A 1941 photograph depicts a different fixture that is perhaps more historically accurate (fig. 48). Four metal flagpole holders extend eastward from the base of the balustrade above the cornice, within the middle third of the semicircular arc.

A bell hangs from the cement slab at the south opening (fig. 48). Suspended from an iron mounting, it displays the following inscription:

Although the clapper is no longer in place, one apparently had been installed at some point because it did exist in 1941 (fig. 48).

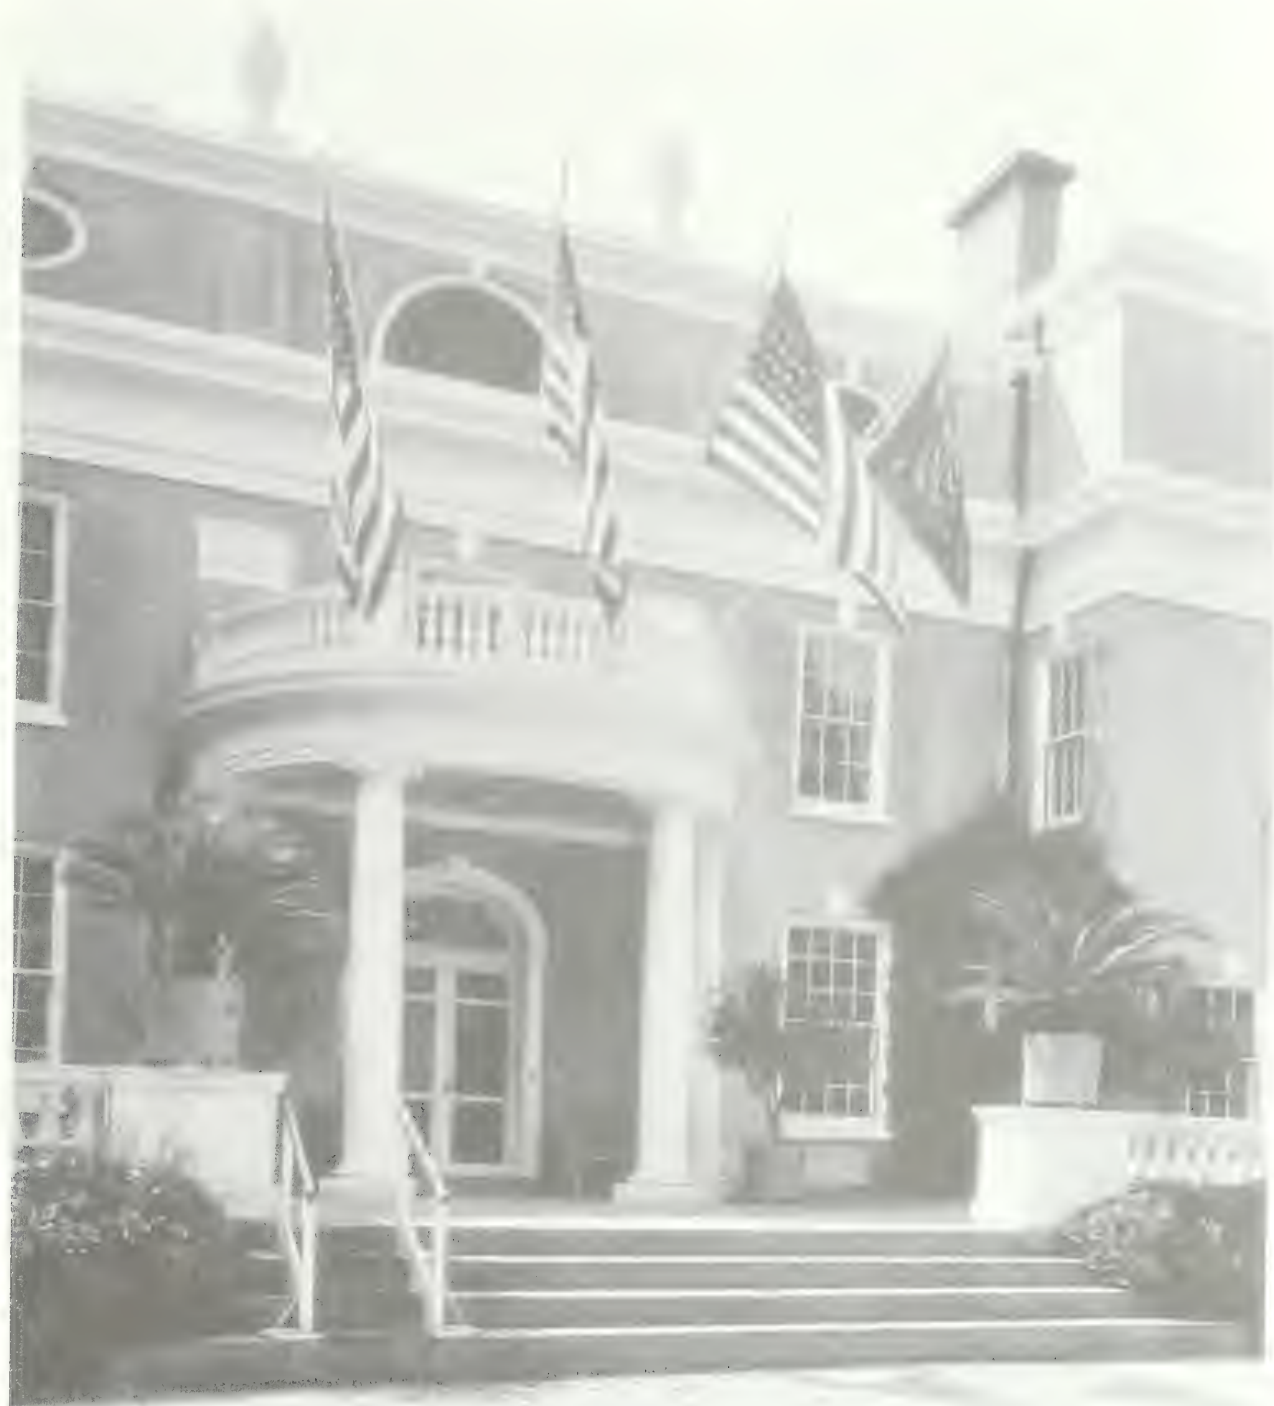
Figure 49. Home of FDR: Entrance portico, 1941.

The south porch (fig. 51) covers much of the first-story south wall of the south wing (fig. 49). Like the wing, it dates to 1915. The porch extends across the south sides of, and between, the two bays on this wall.

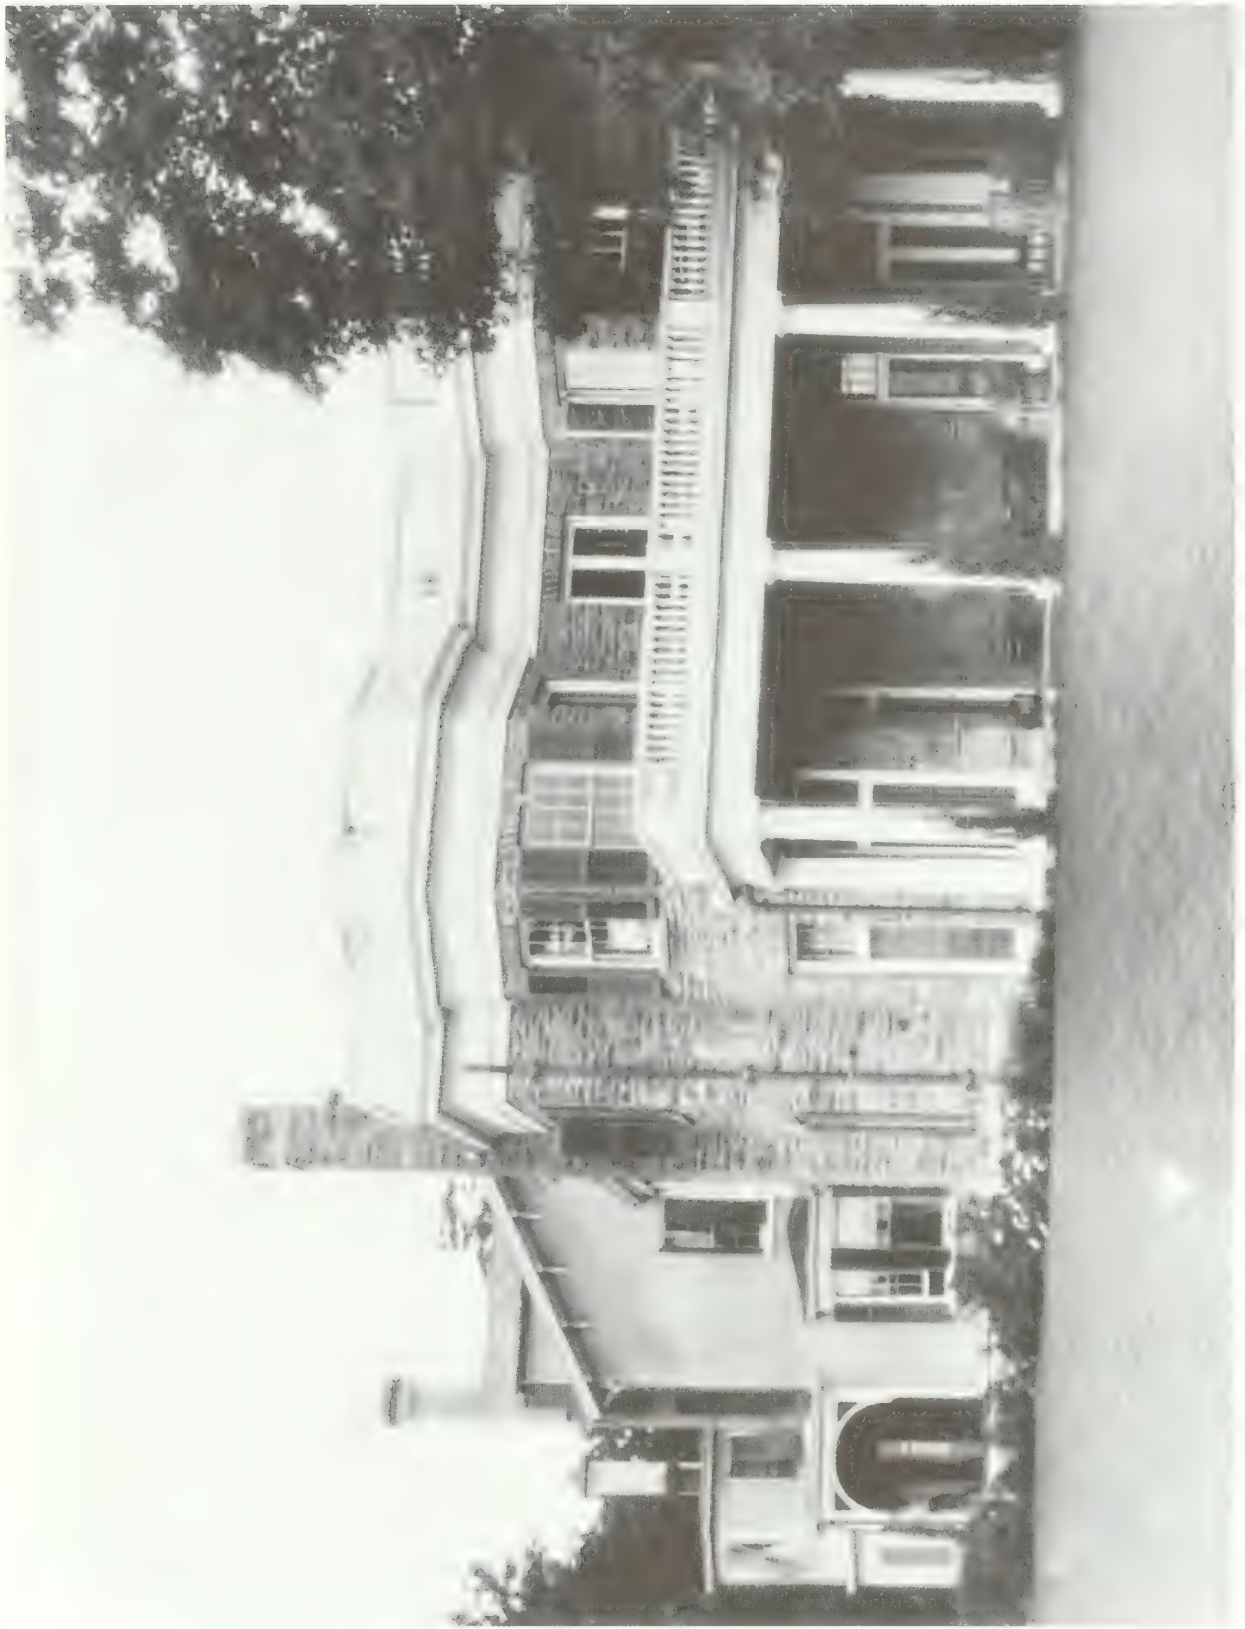
Figure 51. Home of FDR: South elevation, n.d.

A photograph of the south porch taken before the vegetation was overgrown does not reflect the screened enclosure (fig. 51), nor is it depicted in the 1915 alteration plans (Appendix A, Drawing No. 6). However, it is evident in a 1941 HABS photograph showing an abundance of vegetation (fig. 52), but not in the HABS drawings of the same date (Appendix B, sheet 2). Based solely on the photographs and the comparison of vegetation growth, the screened enclosure may have been added ca. 1930. A NPS photograph of the same area taken during the winter ca. 1946 (fig. 51) suggests that the screening was a permanent fixture that was not removed during the colder months. Although the NPS may have overlooked the enclosure's seasonal removal, they had been instructed through legislation and FDR's legacy to make no changes after his death. Since he died in early spring the prior year, the enclosure may have weathered the winter of 1945 due to his wishes.

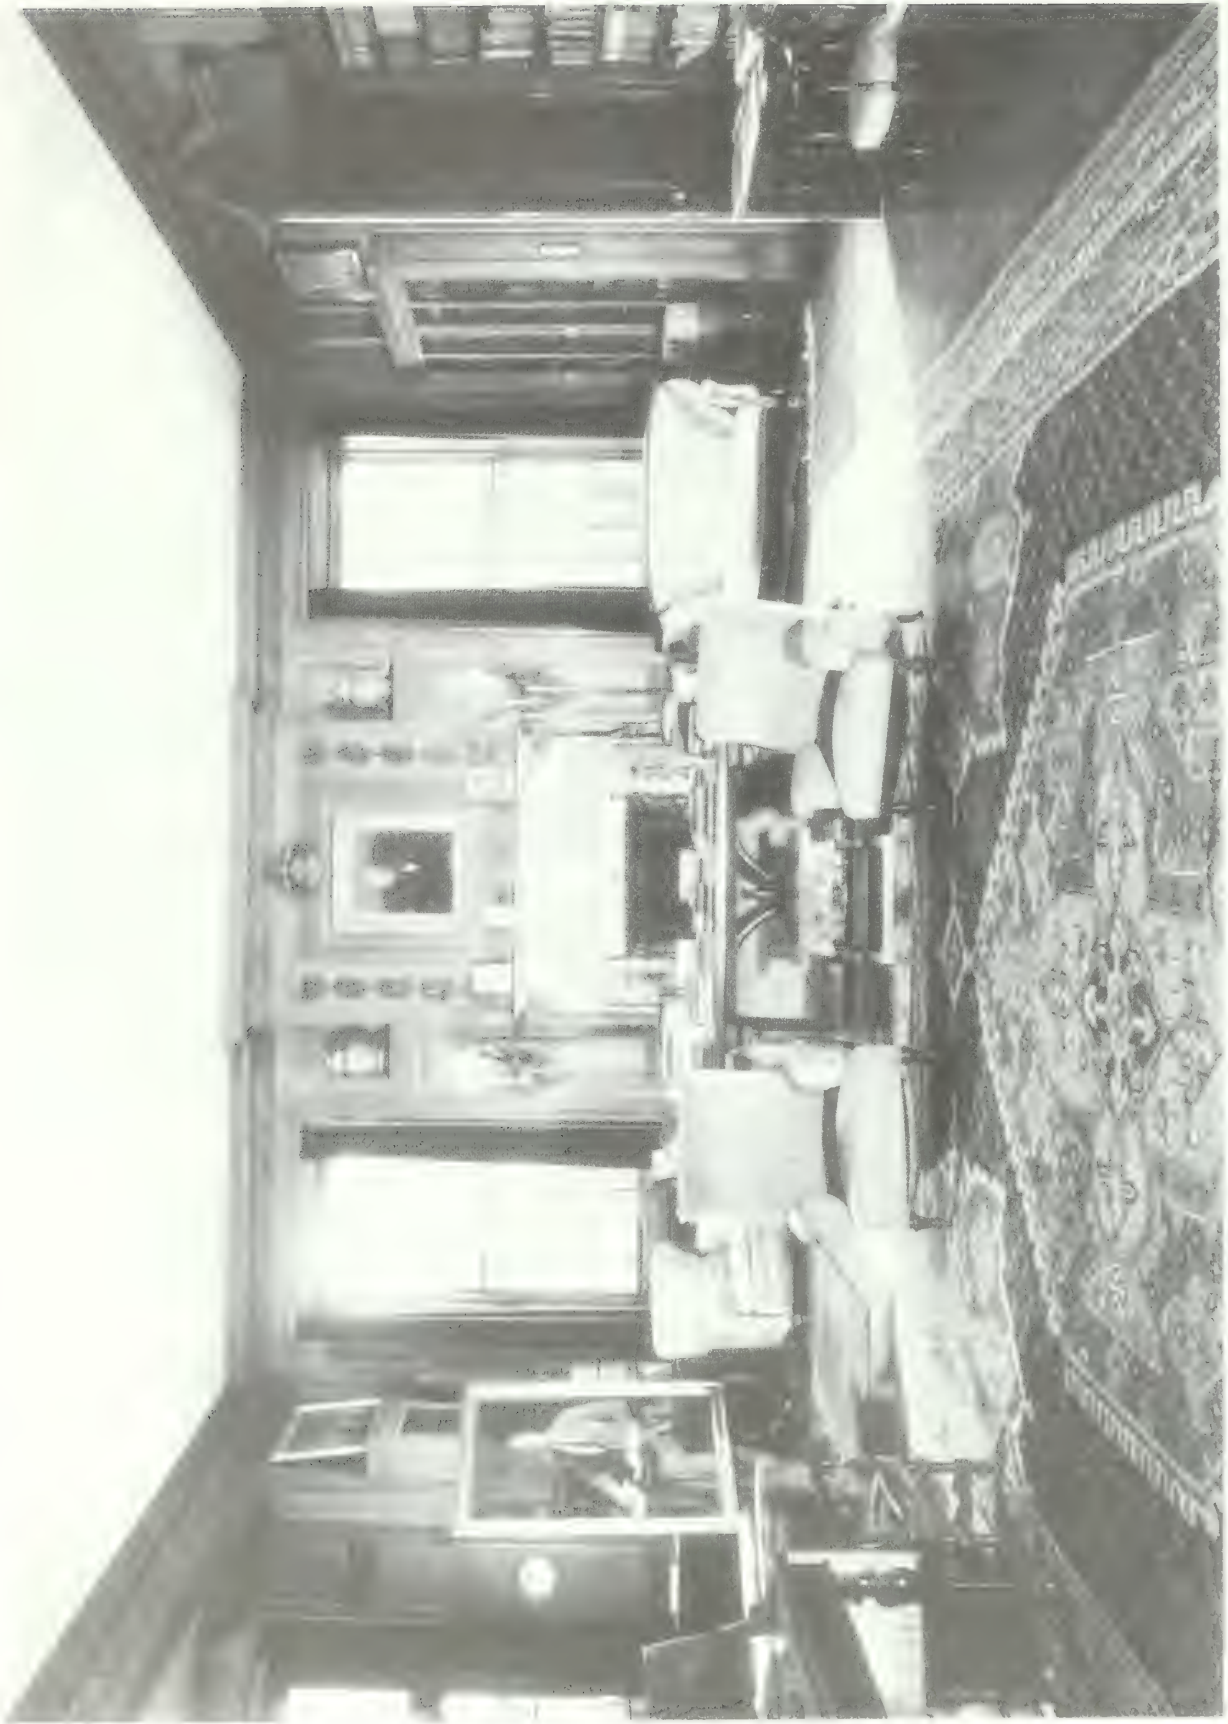
Figure 58. Home of FDR: Library/Living Room, looking west, 1941.

This room (fig. 58) was part of the 1915 south-wing addition. Primary features include two bay windows in the south wall, and two fireplaces, on the east and west walls opposite one another. The doorways and windows in the bay are depicted in Appendix B, sheets 19-20; wall elevations are seen on sheet 25; the profiles of the cornice, wall paneling, architraves, and shelving are on sheet 26; and the ceiling moldings and mantels are on sheet 27.

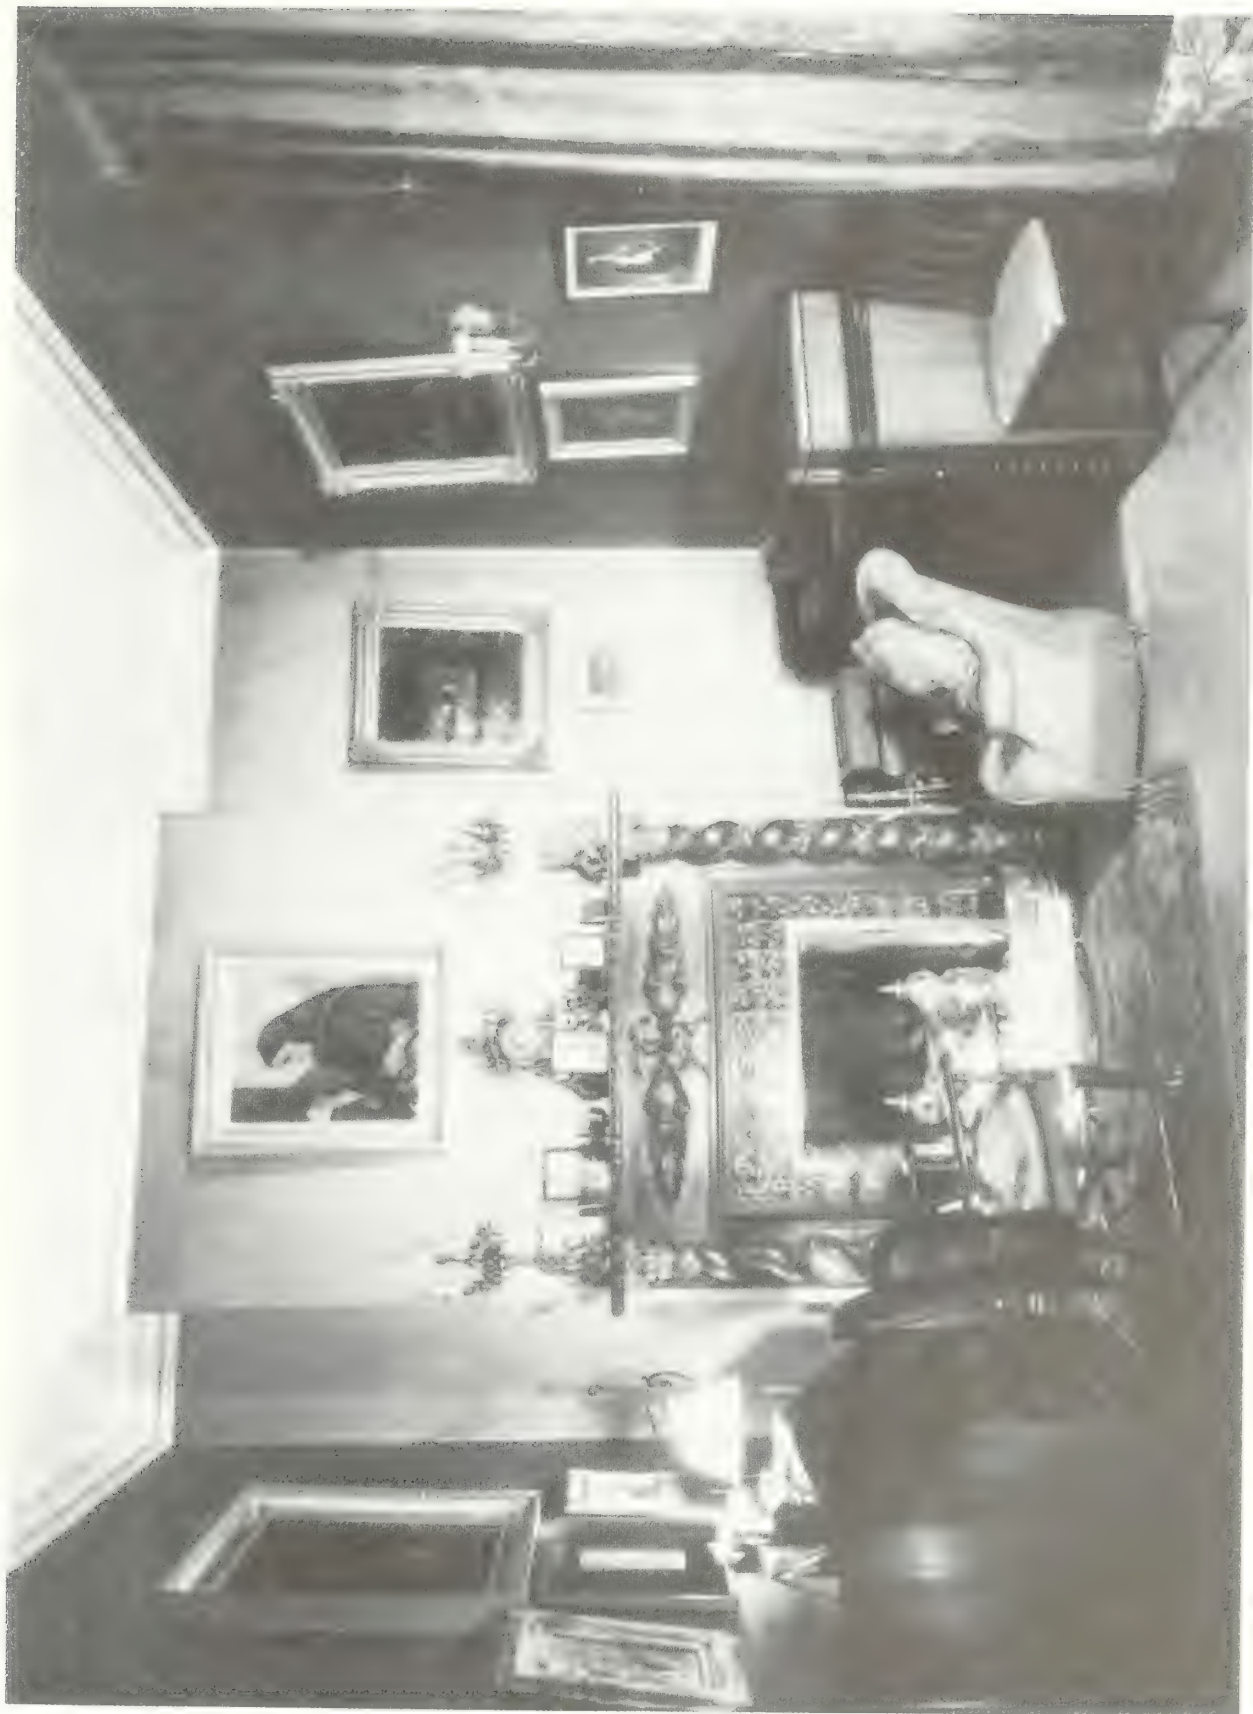
Figure 59. Home of FDR: Snuggery, looking north, 1941.

This room (fig. 59) dates to ca. 1850, being within the south tower addition. Originally it was almost twice as large as it is today, and was known as the South Parlor. However, its west side was taken in 1915 to create the Gallery. Since that time, the space has been known as the Snuggery. However, the Historic American Buildings Survey drawings call it the South Parlor. Details of the room are seen in Appendix B, sheets 19 and 29.

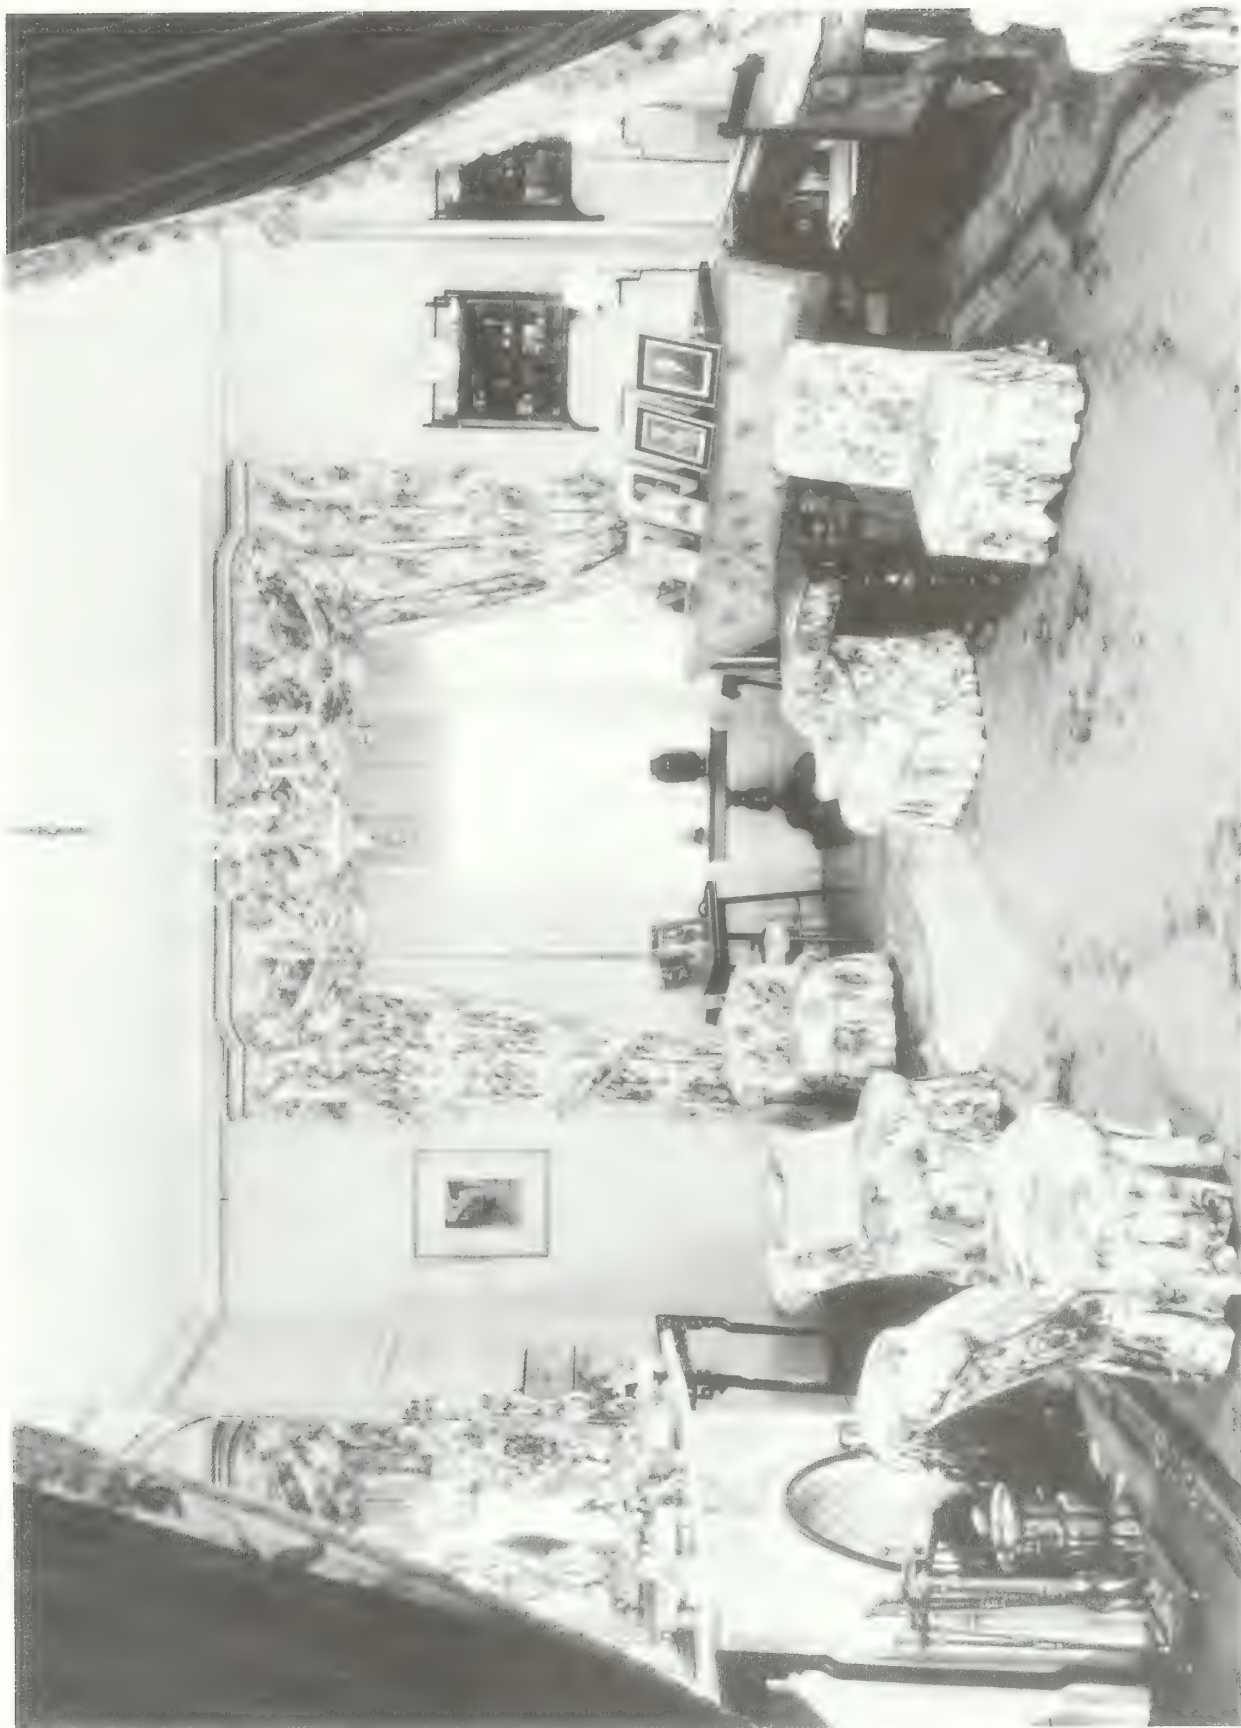
Figure 61. Home of FDR: West Drawing Room, looking south, 1941.

This room (fig. 61) is the original (ca.-1800) southwest room of the main house. Primary features are the fireplace centered on the east wall, and the bay window with three facets comprising most of the south wall. The cornices, baseboard, architraves, west French doorway, and mantel are depicted in Appendix B, sheet 29. Sheet 30 provides additional details of the French doorway.
